NAVAL FIGHTERS NUMBER SIXTY - SEVEN

GRUMMAN
F9F-6P/8P
PHOTO-COUGAR

GRUMMAN F9F6P/8P PHOTO - RECON AIRCRAFT

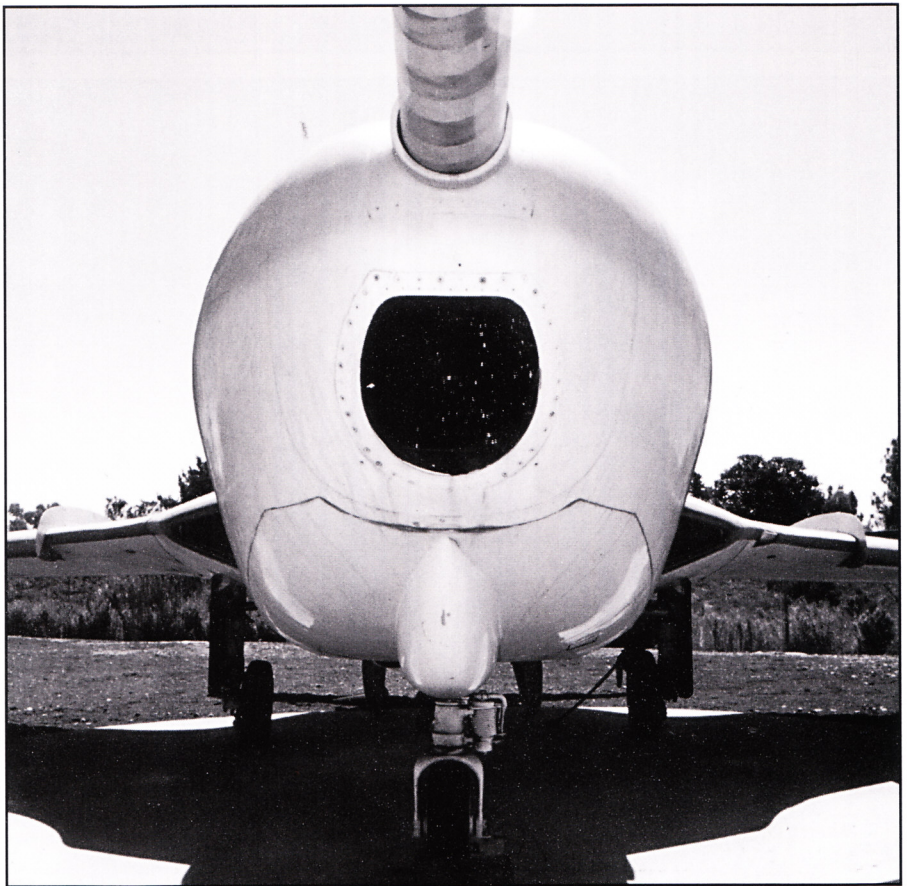
F9F-8P CAMERA INSTALLATION

At right, head-on view of the F9F-8P's nose camera window. (Ginter) Below, close-up of refueling nose probe on the F9F-8P. (Ginter) Bottom, VFP-61 F9F-8P with port and starboard station 2/3 side fuselage doors open. Note camera viewfinder lens just forward of the nose gear. The camera bay interiors were painted non-specular black to limit possibility of reflections. (USN via Don Sperring/A.I.R)

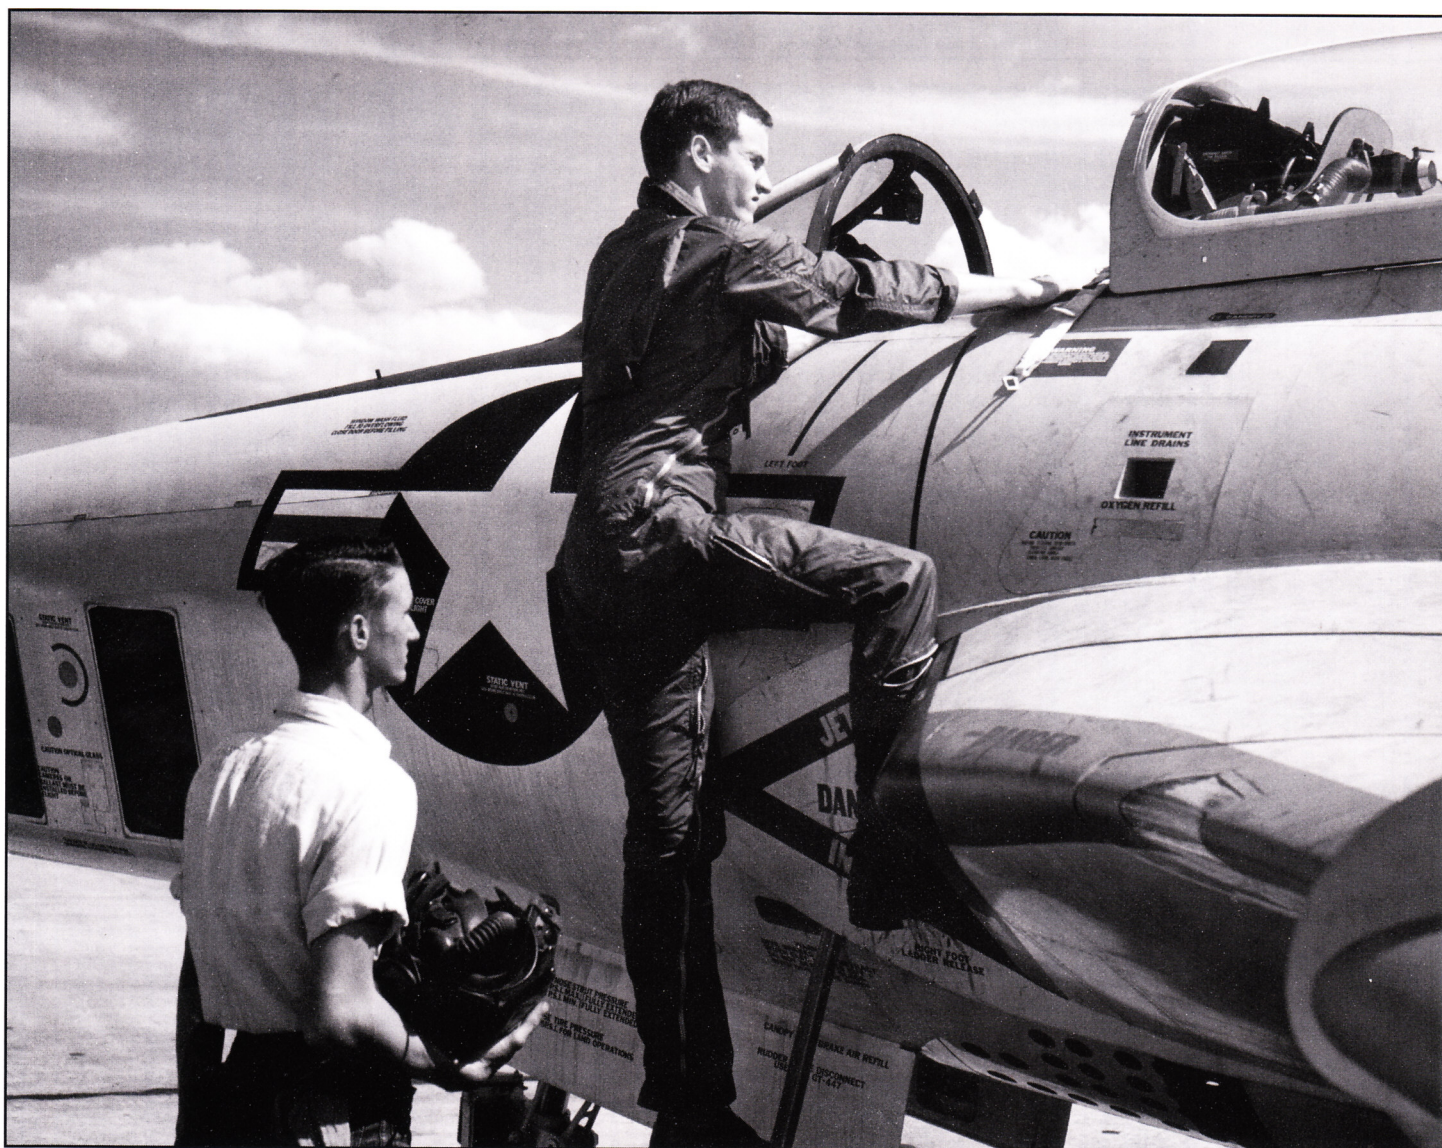
F9F-8P COCKPIT ENTRY AND INTAKE SPLITTER PLATE

Above, pilot climbing into cockpit of an F9F-8P Cougar. He has his left foot on the extended lower step, his right foot in the intake push-in step, prior to bringing his left foot up to the fuselage push-in step. (USN)

At left, close-up of the extended lower step and splitter plate found on the F9F-8P. The intake push-in step can be seen just above the lower intake warning stripe. The fuselage push-in step is located on the red bar portion of the national insignia. Entry to the cockpit was the same for the F9F-6P, too. (Ginter)

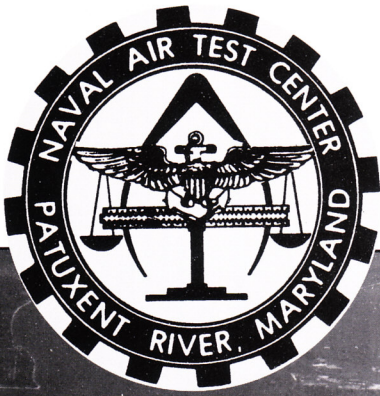
NAVAL AIR TEST CENTER (NATC), NAS PATUXENT RIVER MARYLAND

The F9F-8P was evaluated only briefly at Patuxent River. The evaluation was confined to ensuring that the new extended photo nose profile did not adversely affect flight qualities.

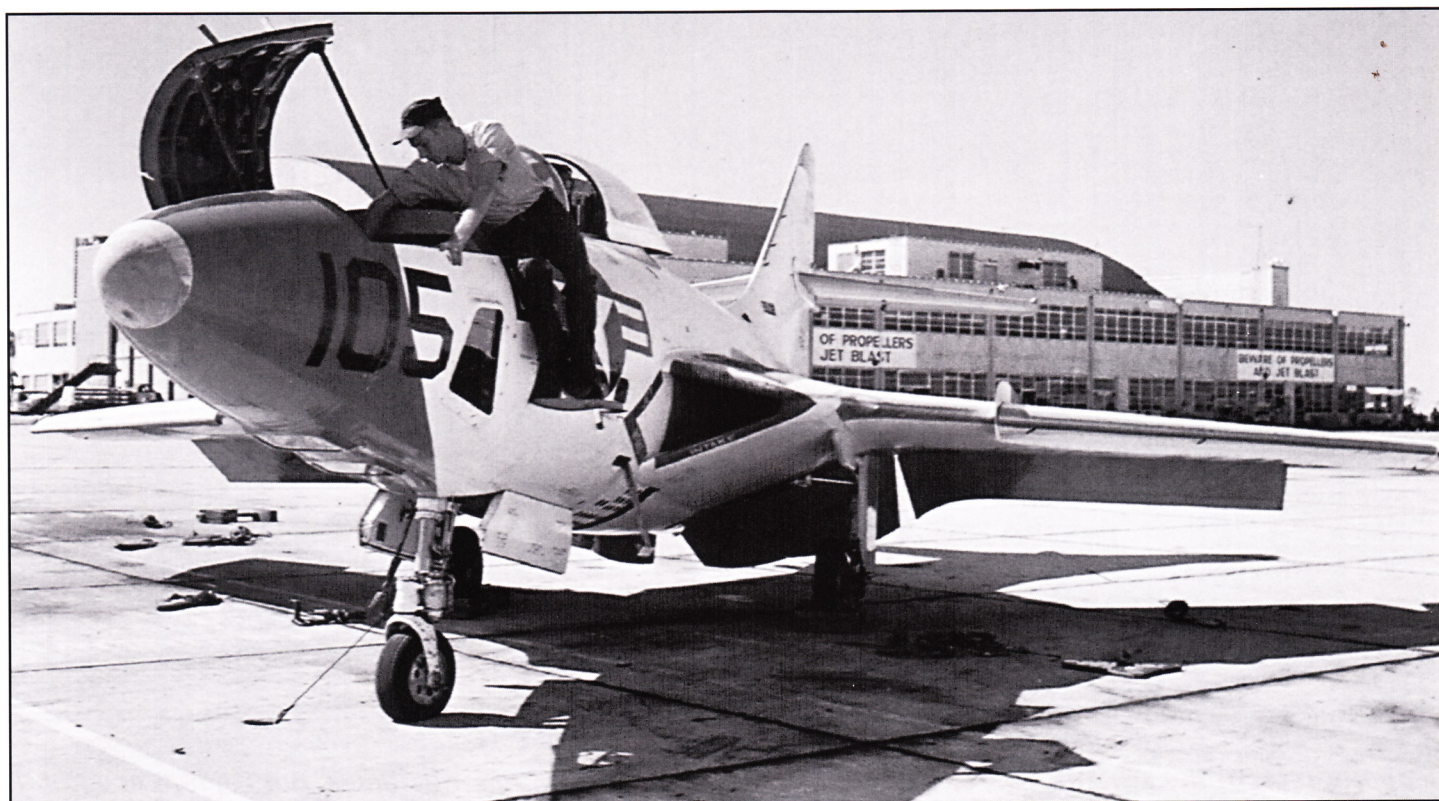
Below, Naval School of Photography F9F-8P BuNo 141671 in flight over the Pensacola area in 1961. (NMNA) Bottom, an F9F-6P assigned to the Pensacola-based unit in 1957. The upper camera bay door was open for maintenance and the flaps were down. (Grumman)

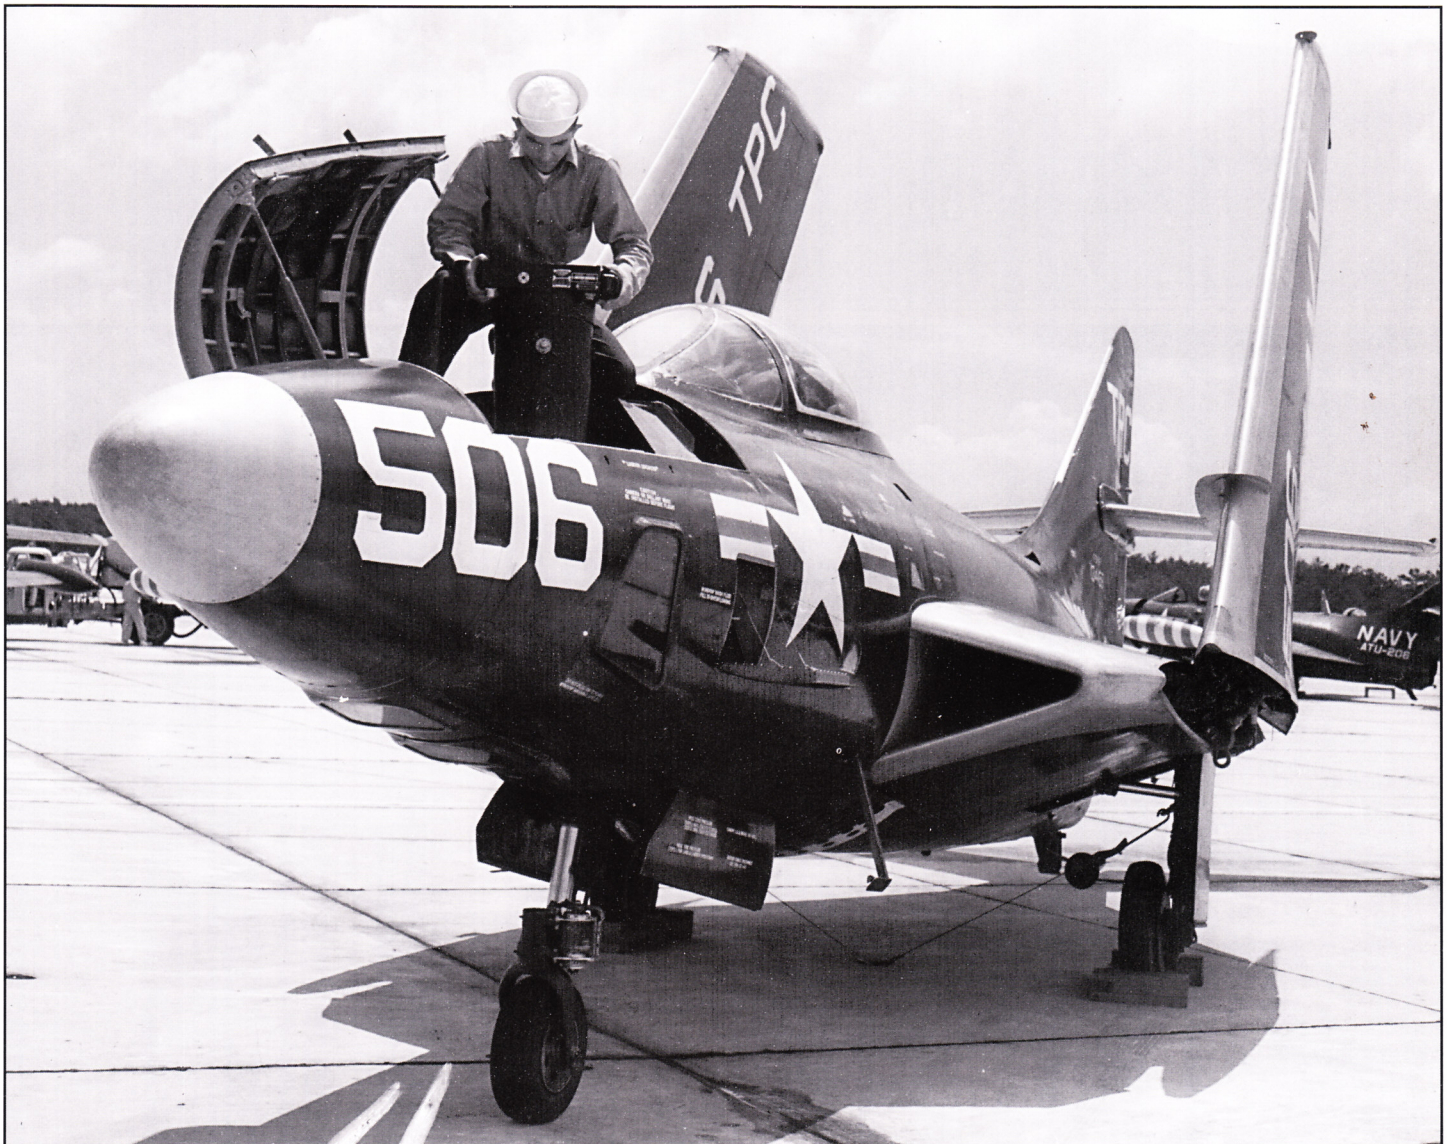
Below, camera loading in an F9F-6P assigned to an unidentified unit "TPC". Anyone having knowledge of this unit, contact Steve Ginter or the Tailhook Association. (NMNA)

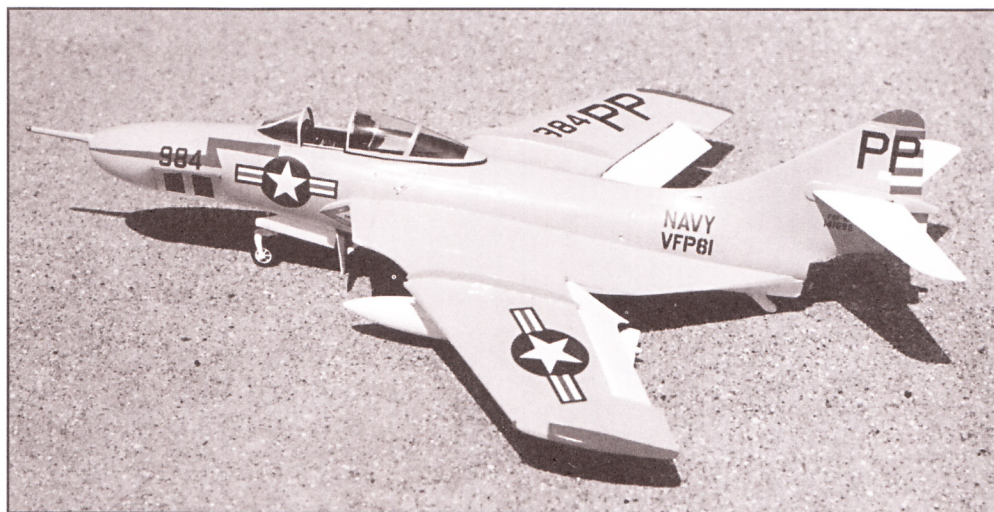
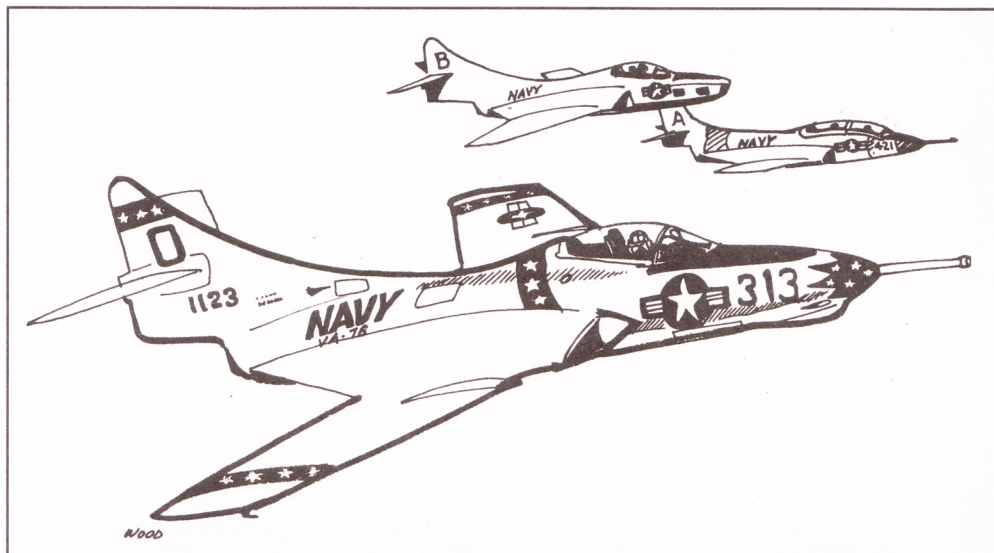
AIRMODEL 1/72 SCALE VACUFORM F9F-8/8P/8T KIT

The 1970's Airmodel vacuform Cougar kit included parts for the F9F-8P photo-recon and F9F-8T two-seat trainer version. As with most Airmodel kits, if there is another choice, take it!
